NBSIR 81-2324 (R)

# Boiling Tests of Non-Asbestos-Based Thermal Insulation Used in Air-Conduit Underground Heat Distribution Systems

September 1981

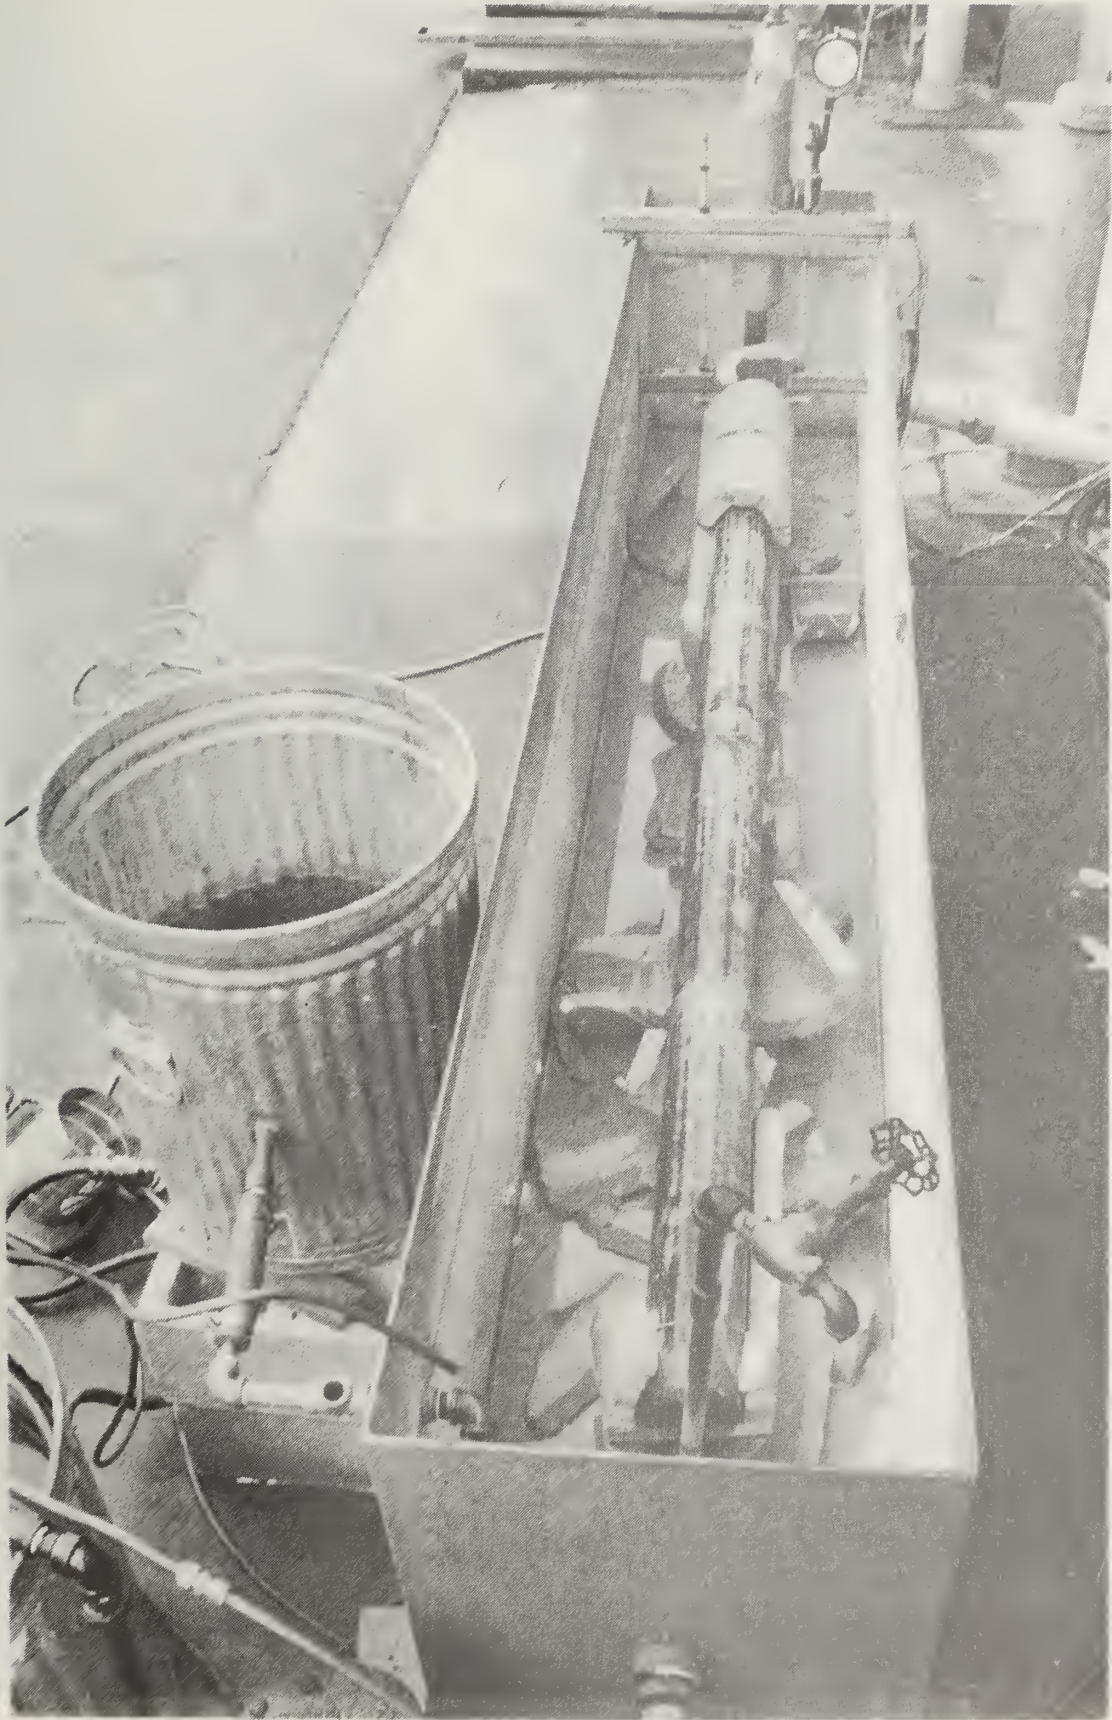
Two Owens-Corning "Kaylo" specimens were tested in the first test -- the insulation was tied onto the 4-in pipe with 16-ga. bare copper wire on 9-in centers, as shown in figure 2. A one-half-section piece is shown (both sides) in figures 3 and 4, and figure 5 shows the results after 5 hours of boiling. This insulation started to crack off of the pipe after about 30 minutes of

Figure 5. KAYLO #1 system after 5 hours boiling

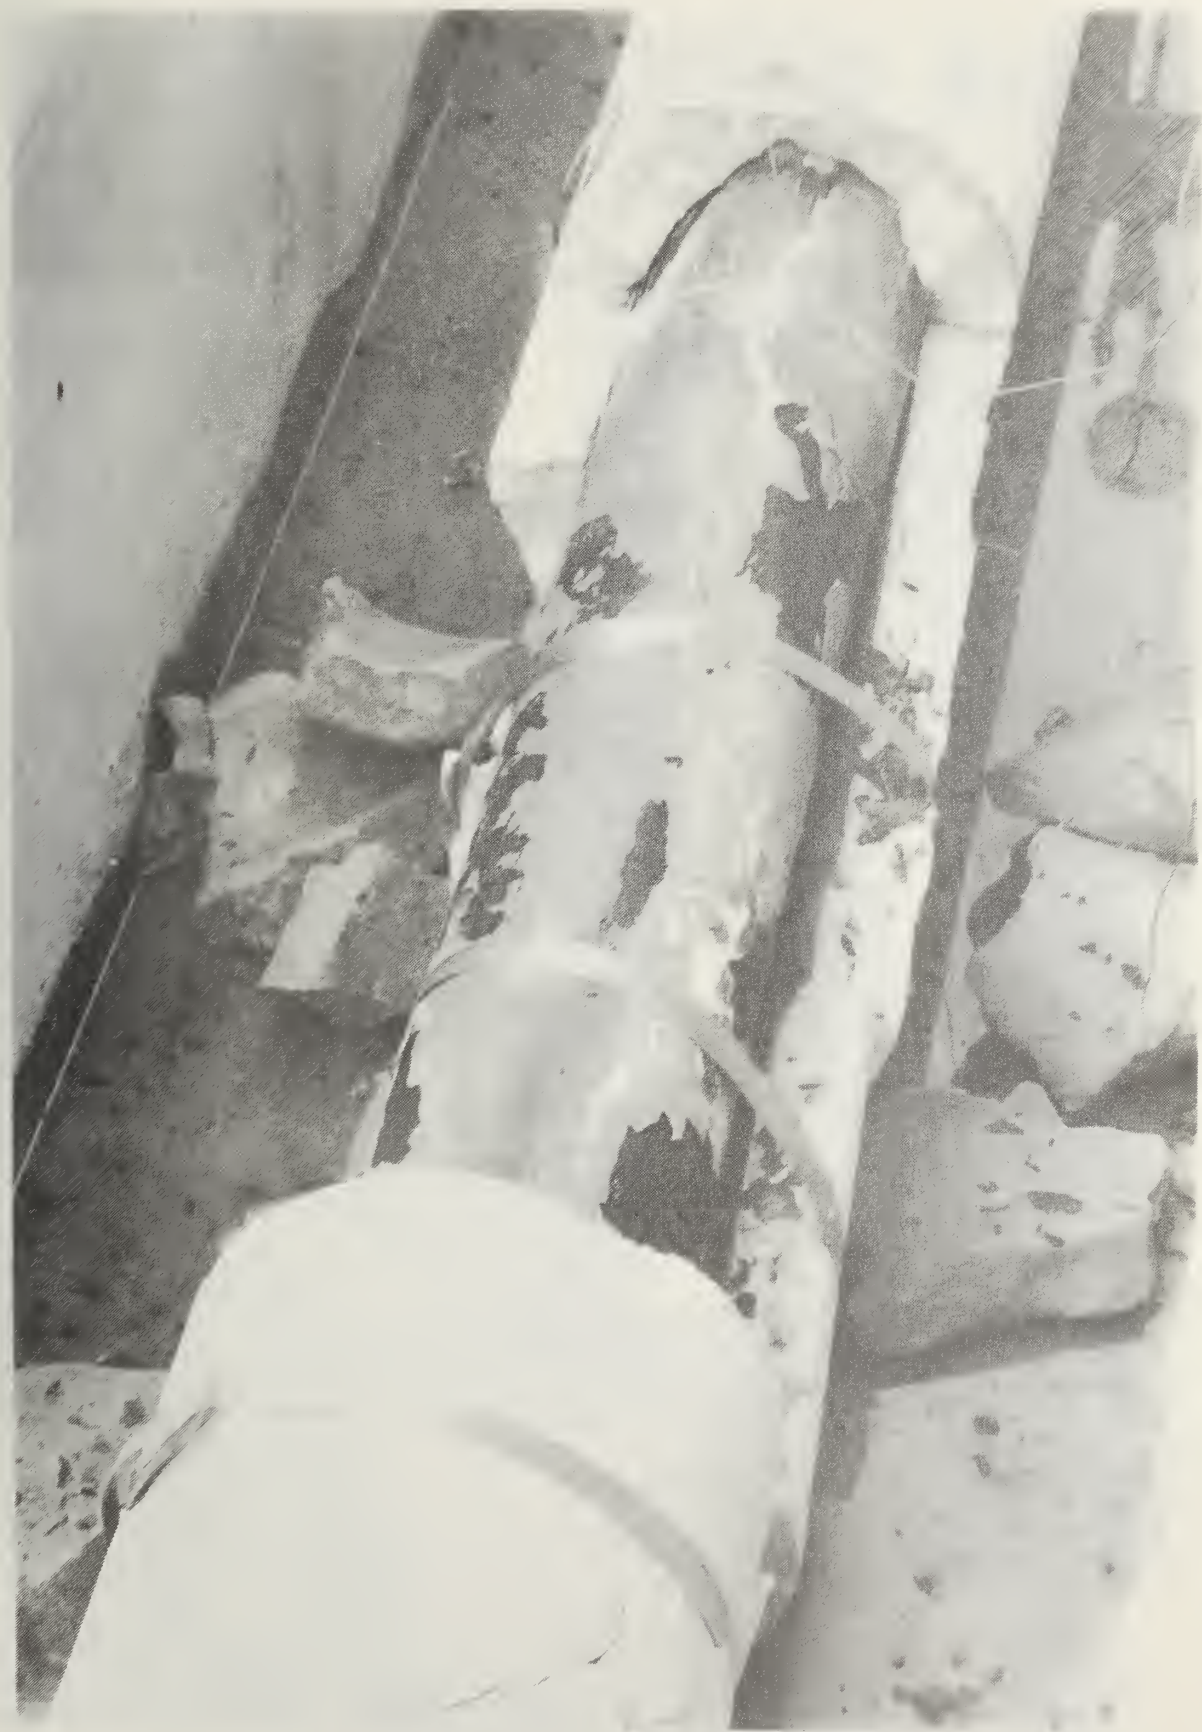
Figure 9. Kaylo #2 system after 72 hours boiling and 24 hours drying.

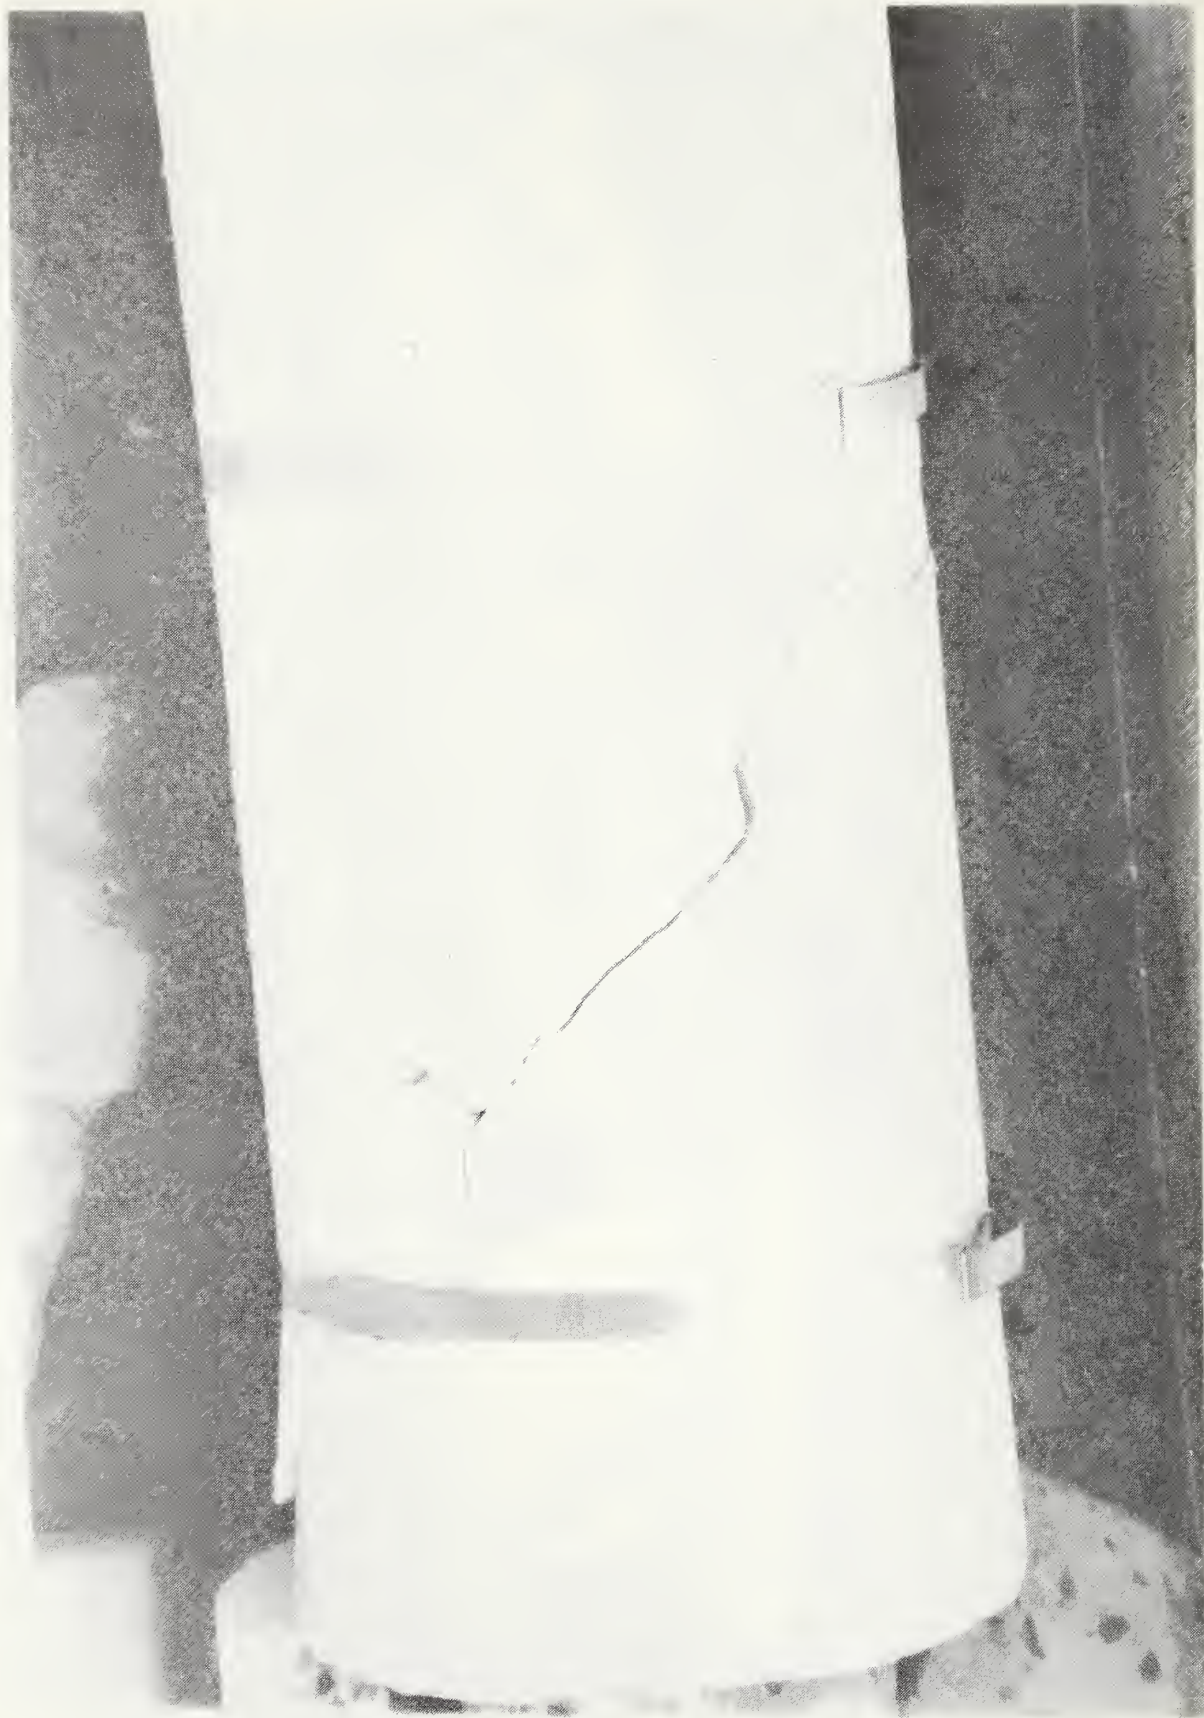
Figure 10. KAYLO #2 after 72 hours boiling and 24 hours drying

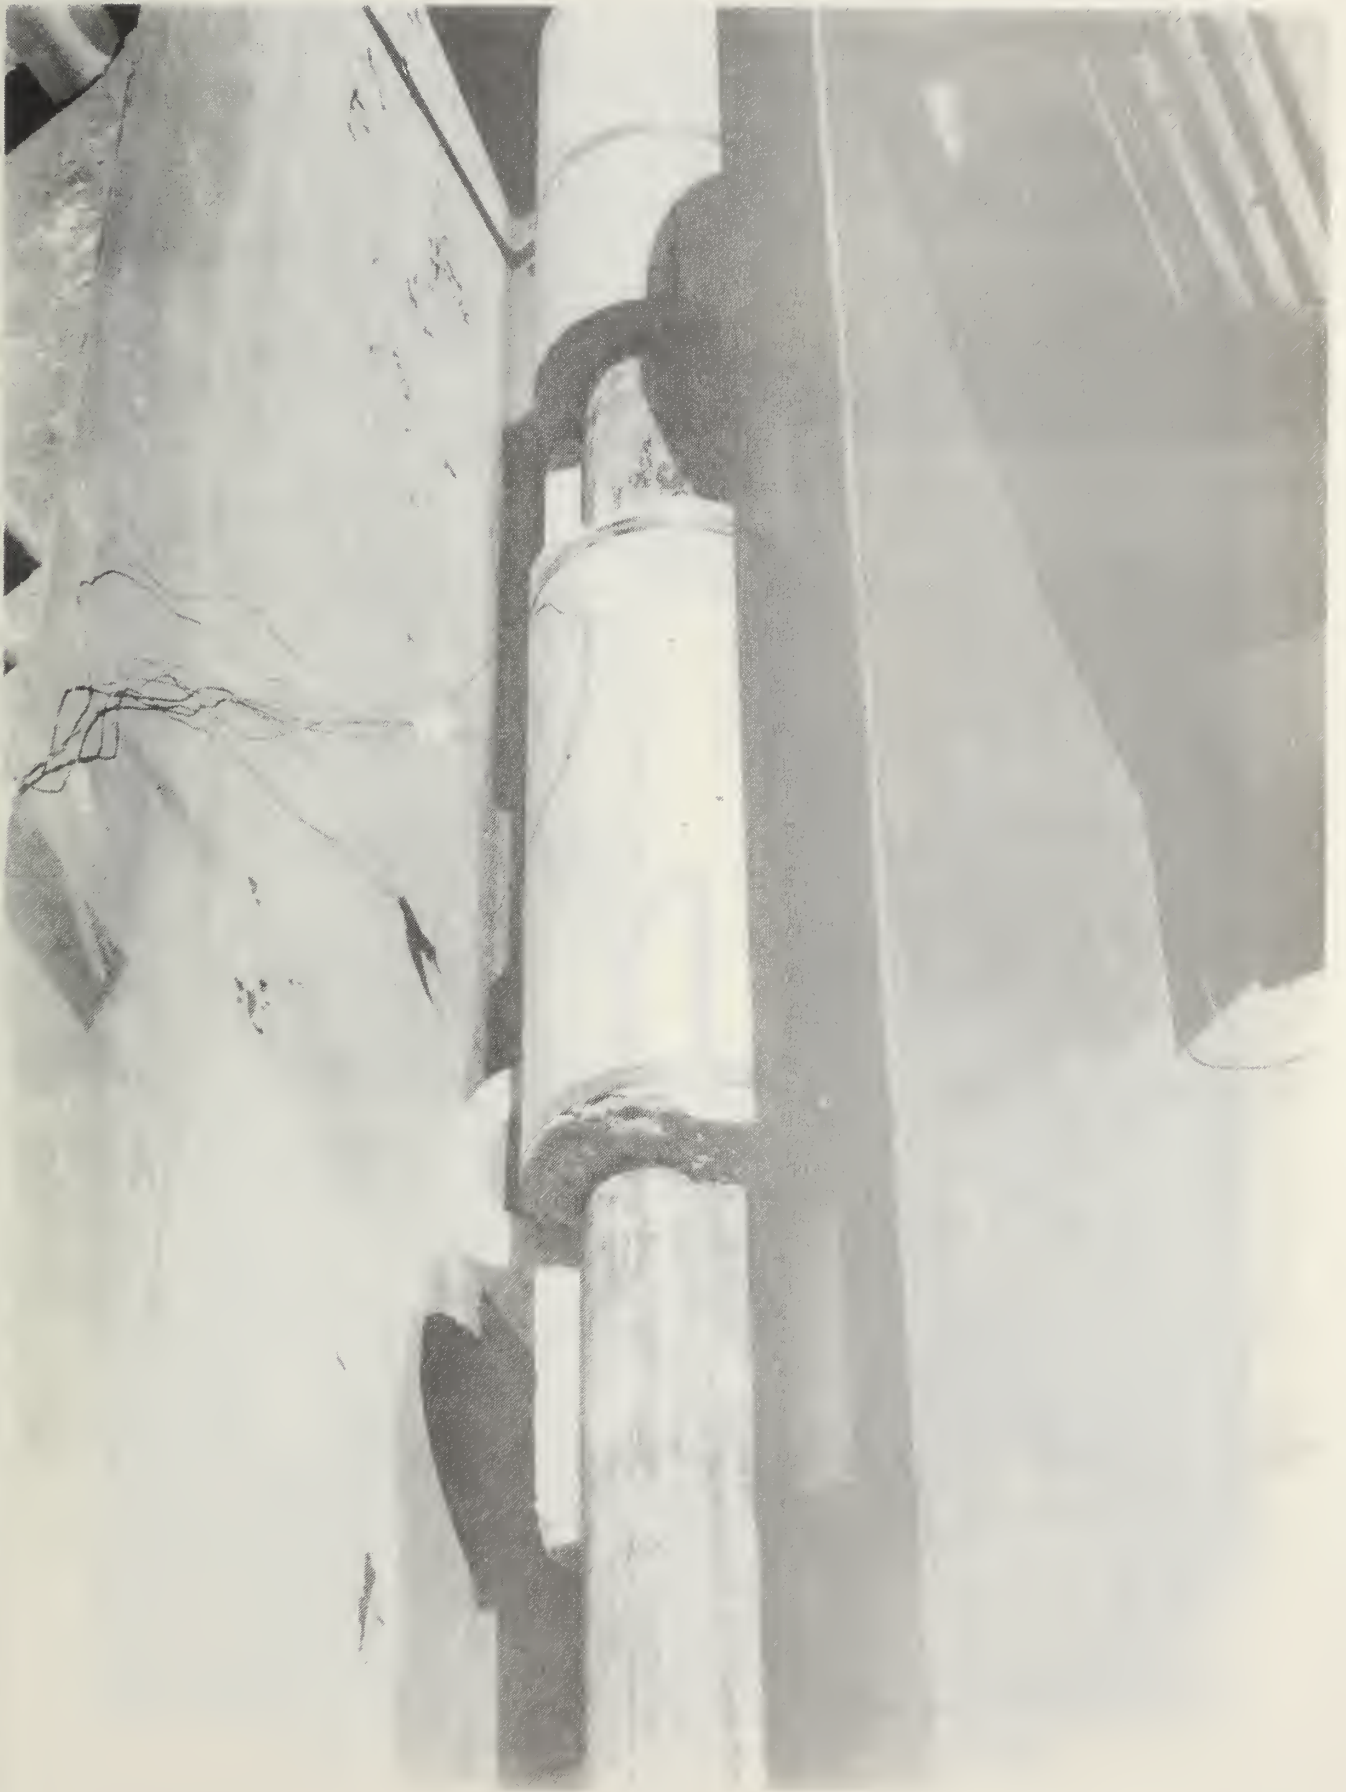
For the first test with Pabco insulation,  $1/2$ -in wide stainless steel bands, were strapped around the pipe on 18-in centers, as shown in figures 11 and 12. One half section piece (both sides) is shown in figures 13 and 14. This insulation started to break off of the pipe after approximately 20 minutes of boiling and all of it came off within one hour. The results are shown in figure 15. The density of this insulation was  $13.79 \text{ lb/ft}^3$  and the moisture content was 5.9 percent.

Figure 15. PABCO #1 system after 1 hour boiling

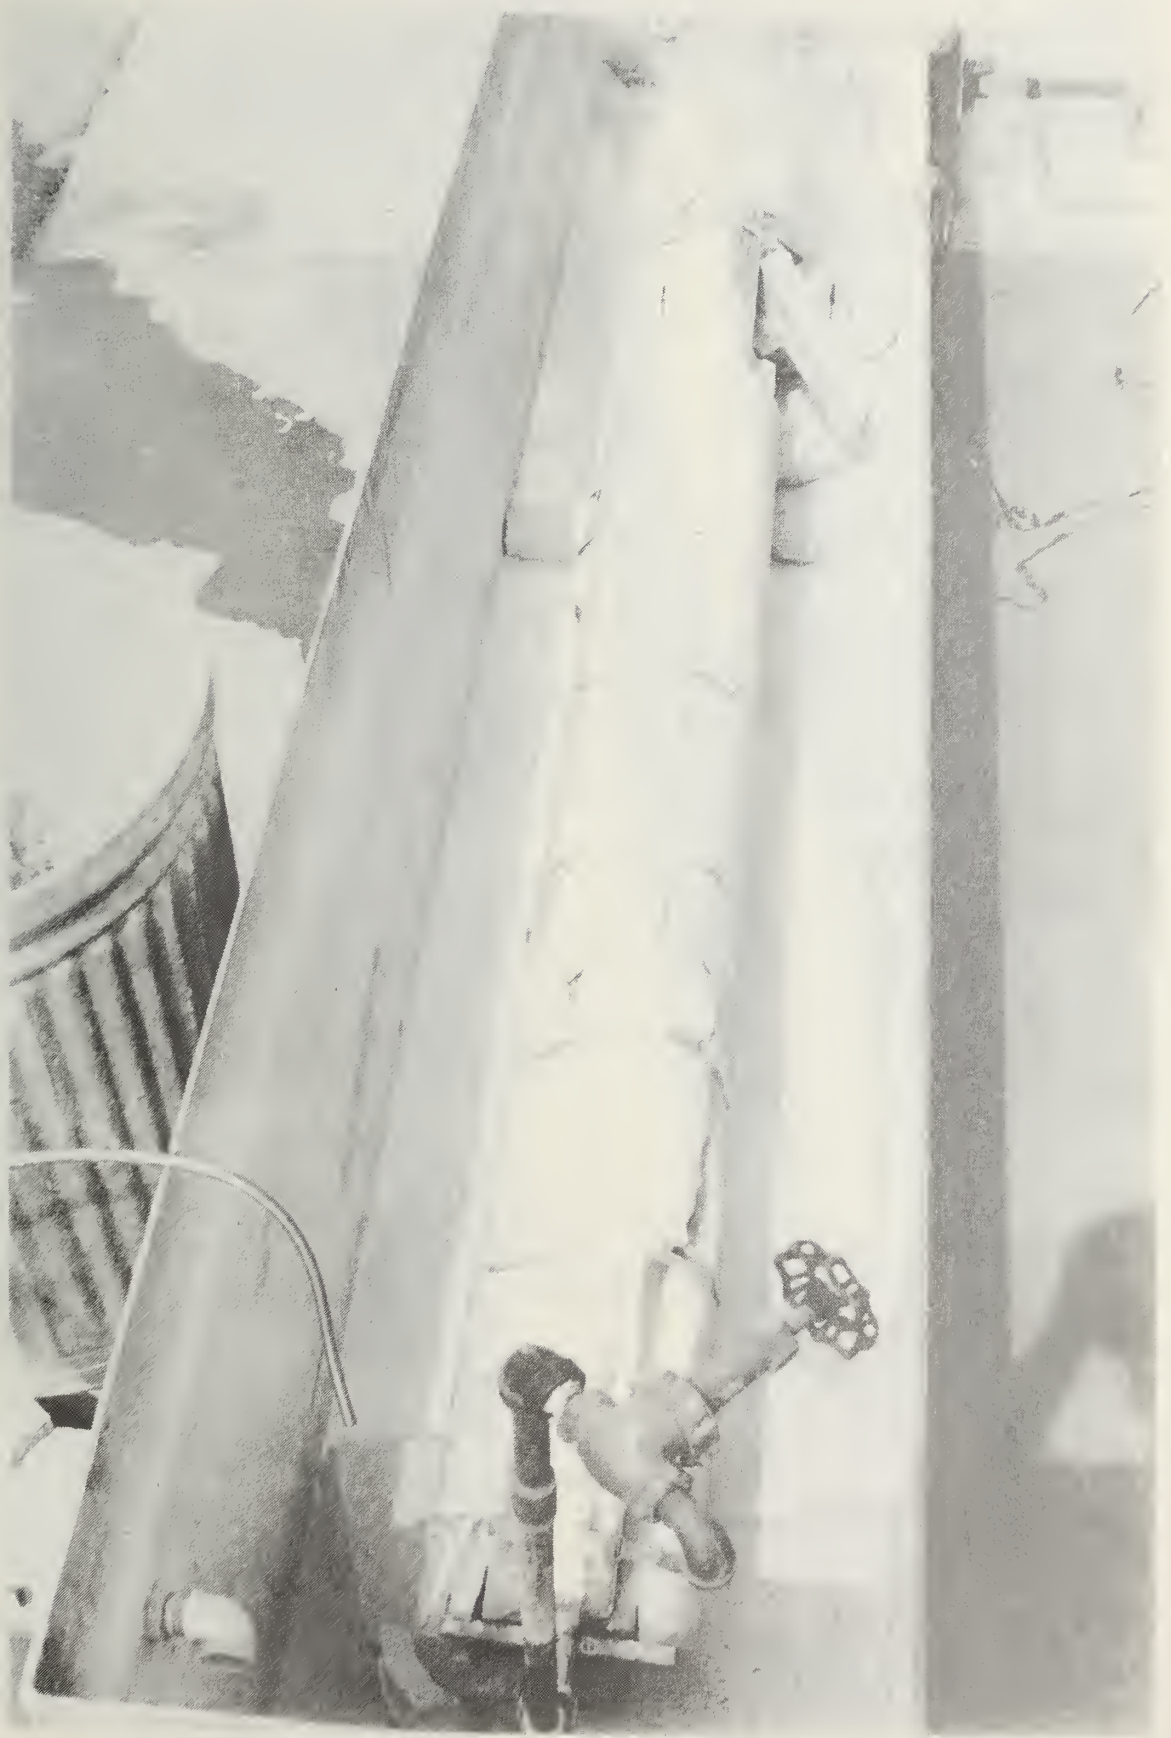
The second test of Pabco insulation was conducted with the insulation installed on the 4-in pipe with 32-ga. stainless steel straps  $1/2$  in wide on 9-in centers instead of 18 inch, as shown in figure 16. One half section (both sides) is shown in figures 17 and 18. The results of 3 hours boiling are shown in figures 19 and 20. The density of this insulation was  $14.40 \text{ lb/ft}^3$  and the moisture content was 3.4 percent.

Figure 19. PABCO #2 system after 3 hours boiling

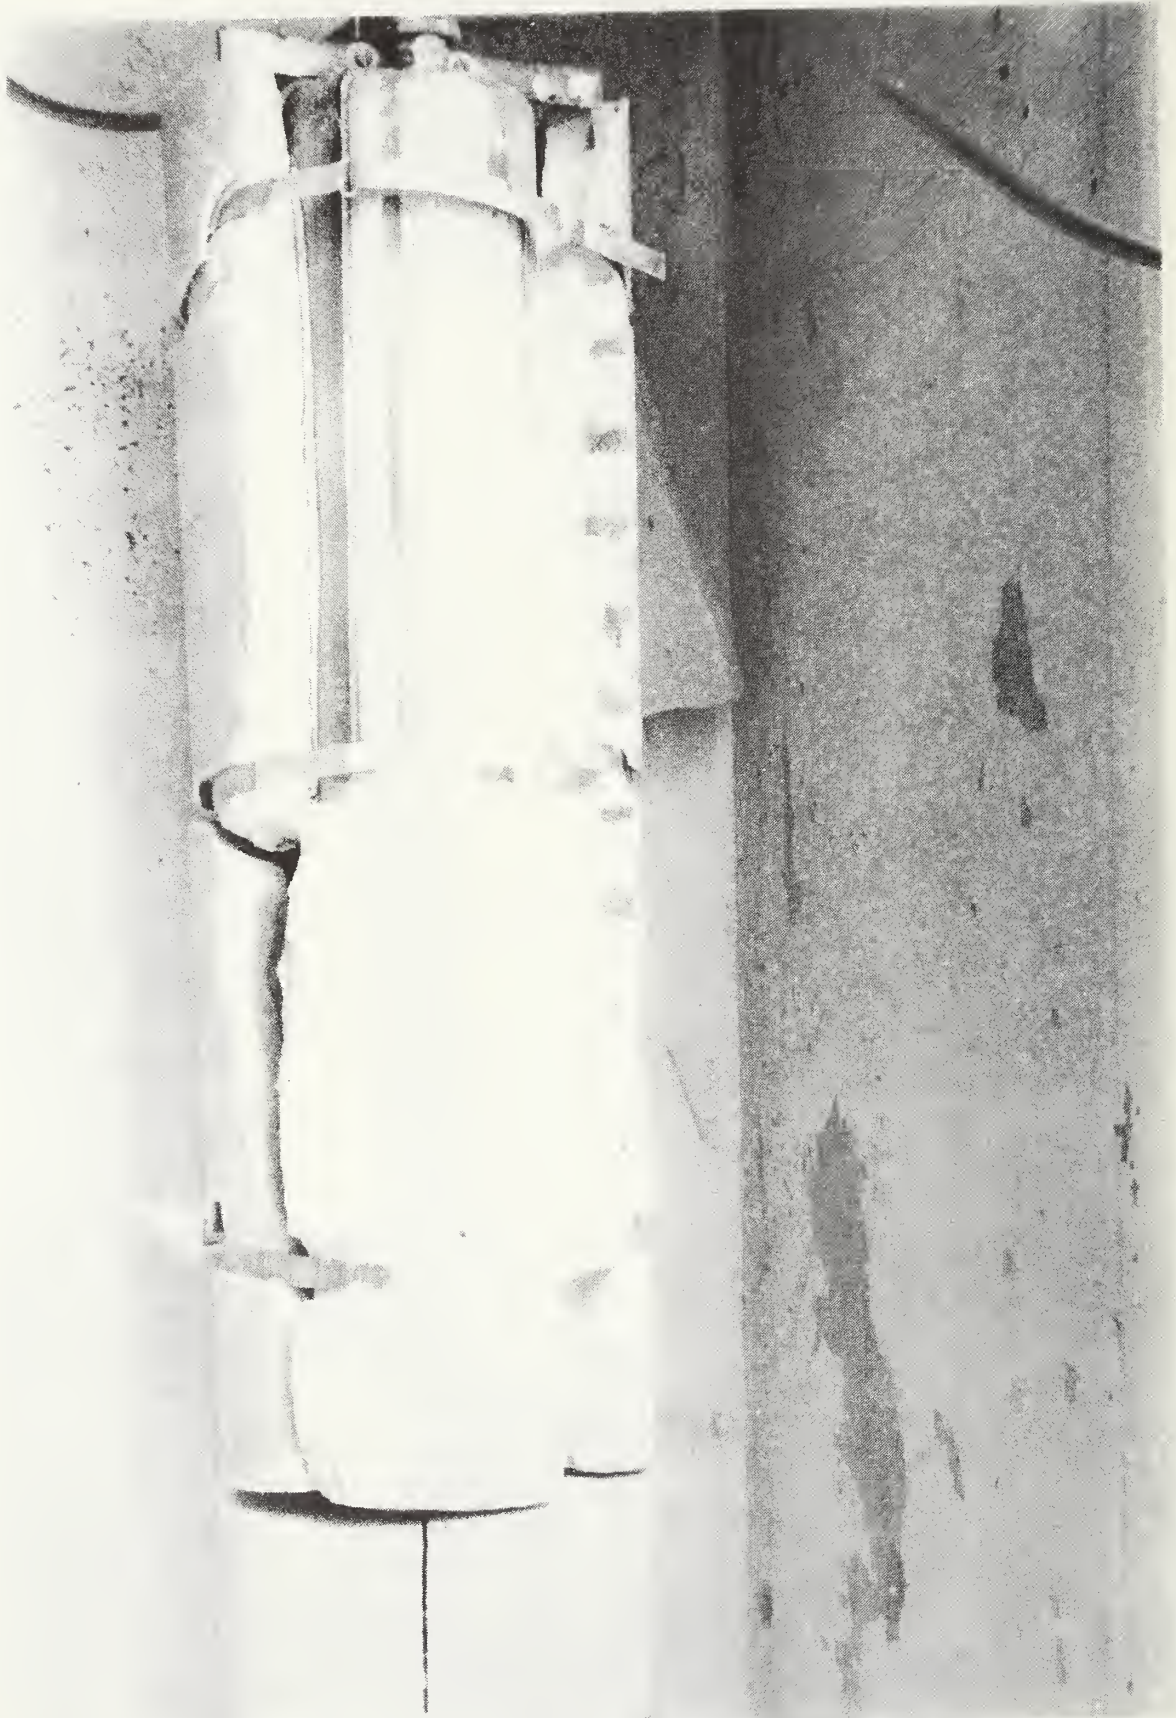
Figure 20. A close-up of PABCO #2 system after 3 hours boiling

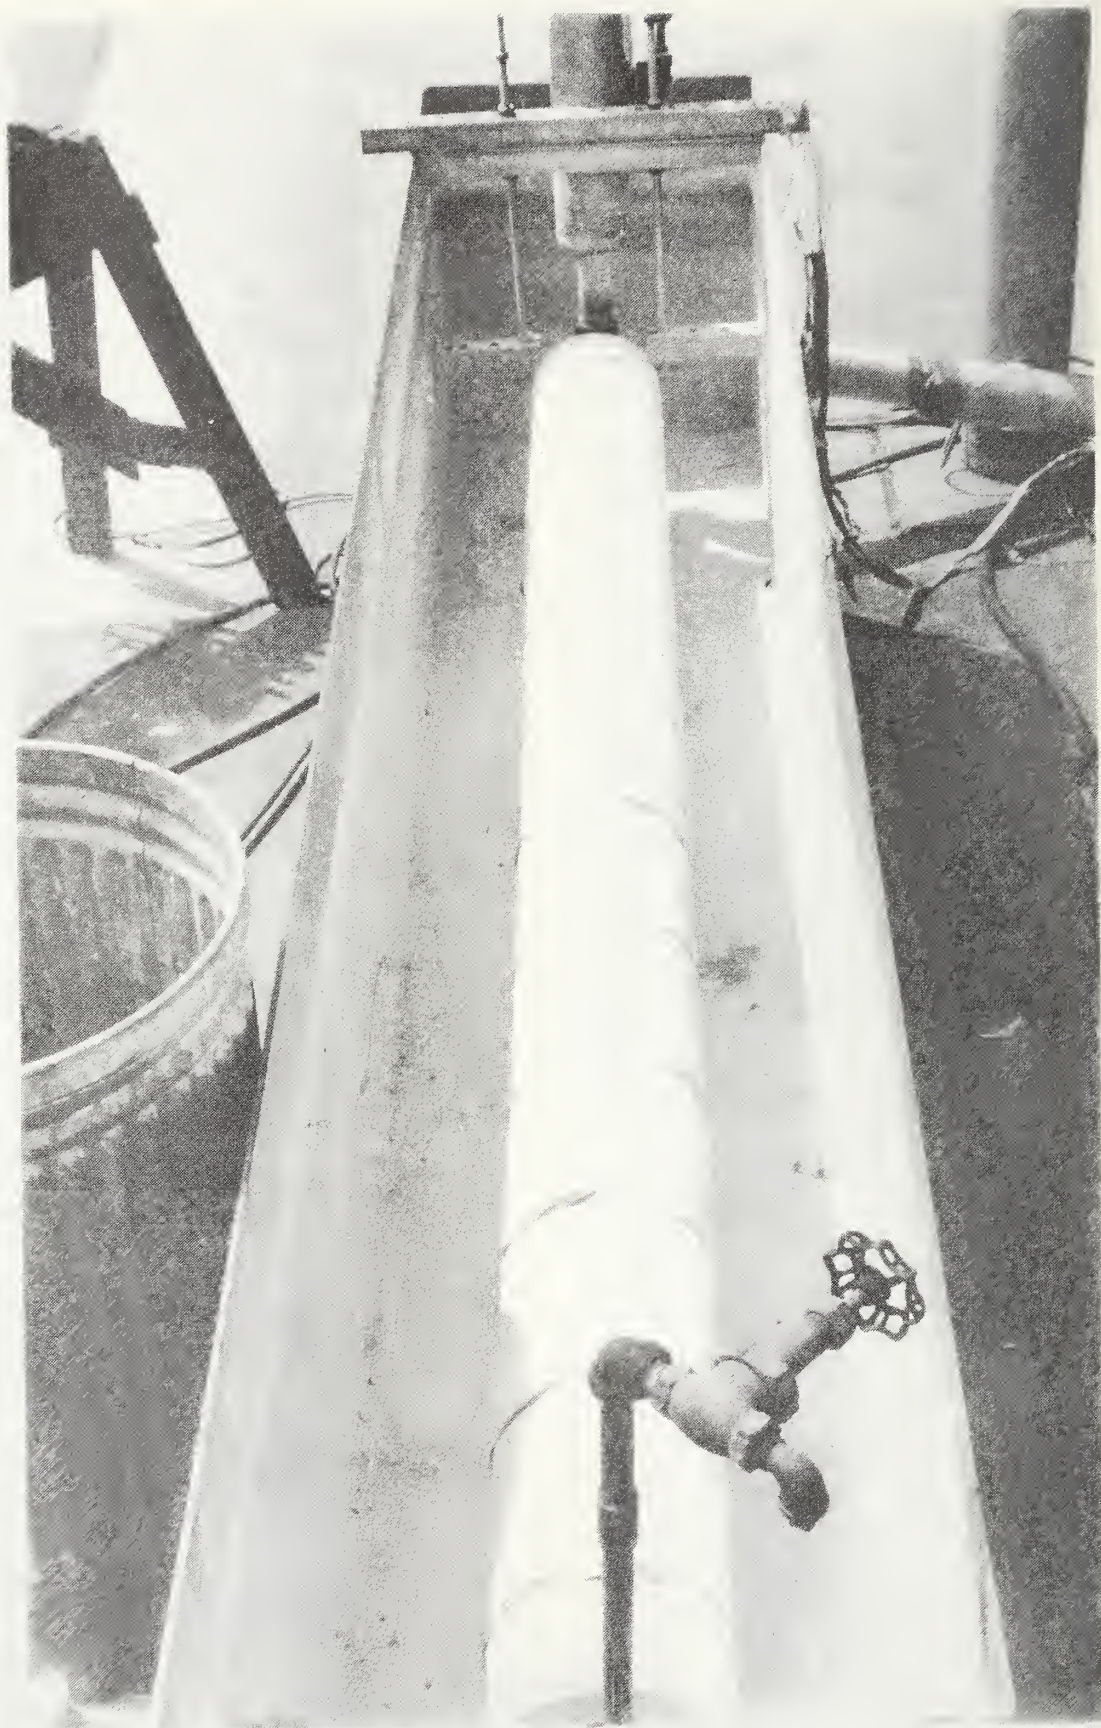
Figure 24. J/M system after 72 hours boiling and 24 hours drying

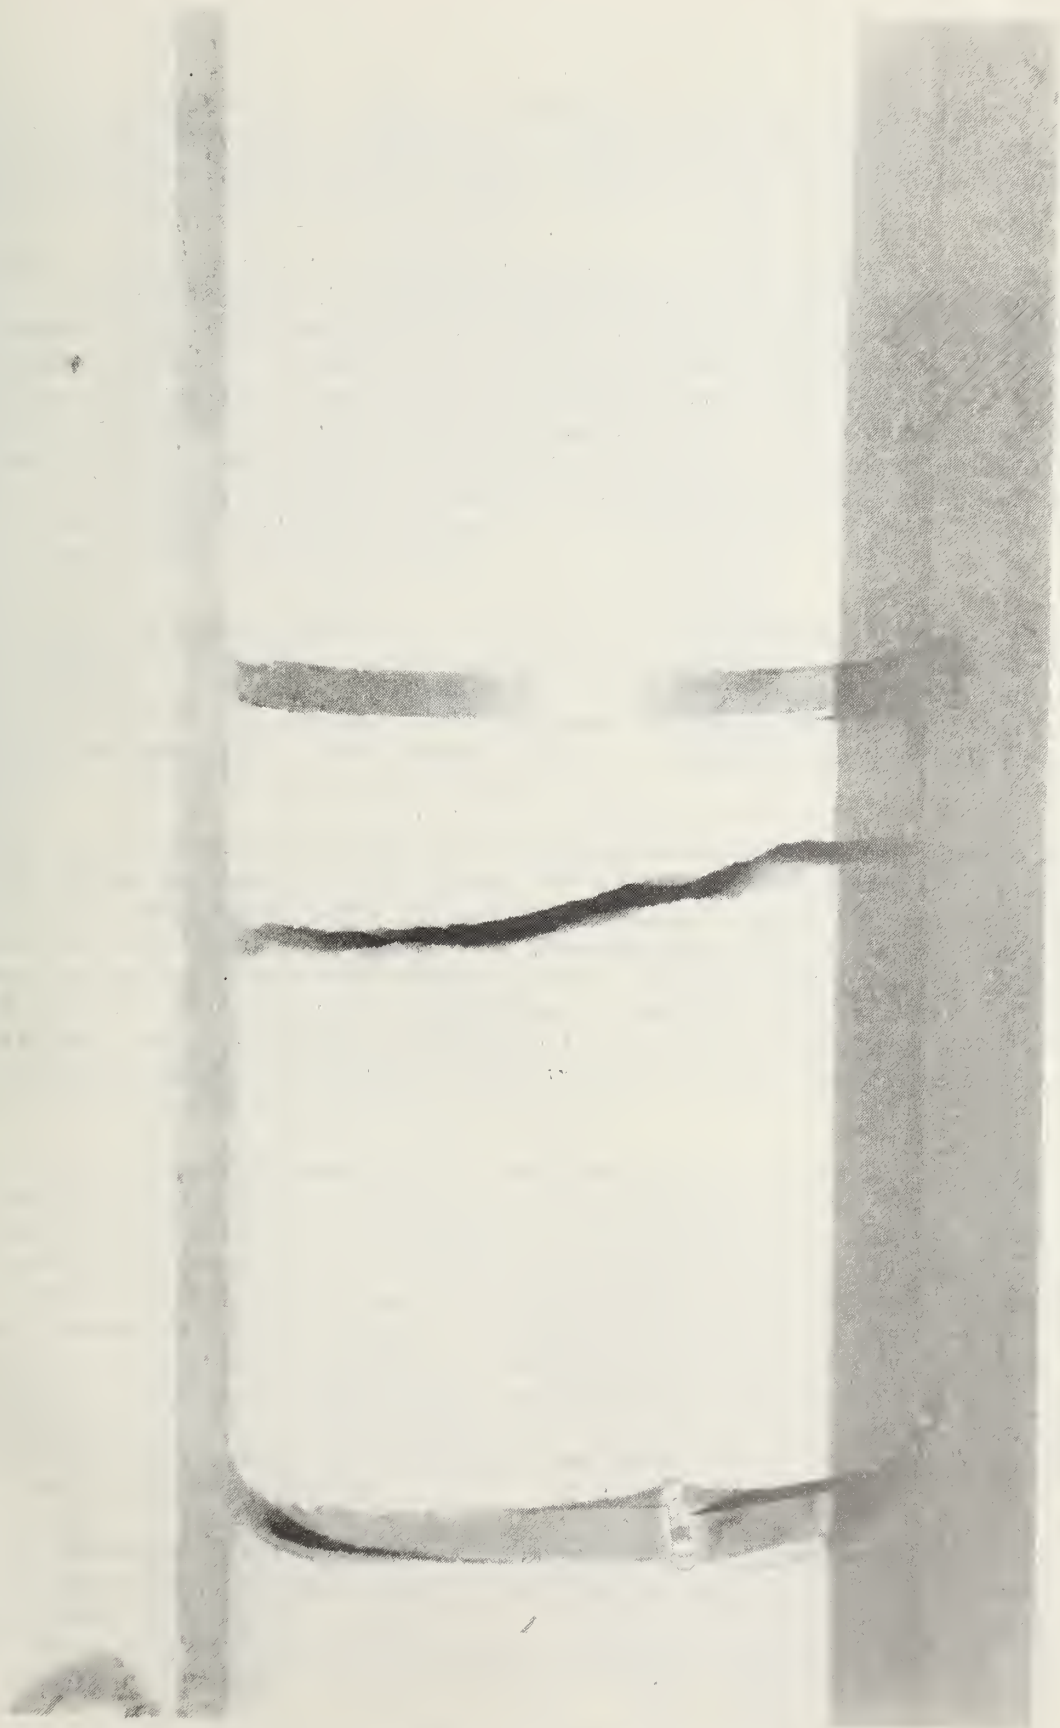
Figure 25. Close-up of J/M system after 72 hours boiling and 24 hours drying.

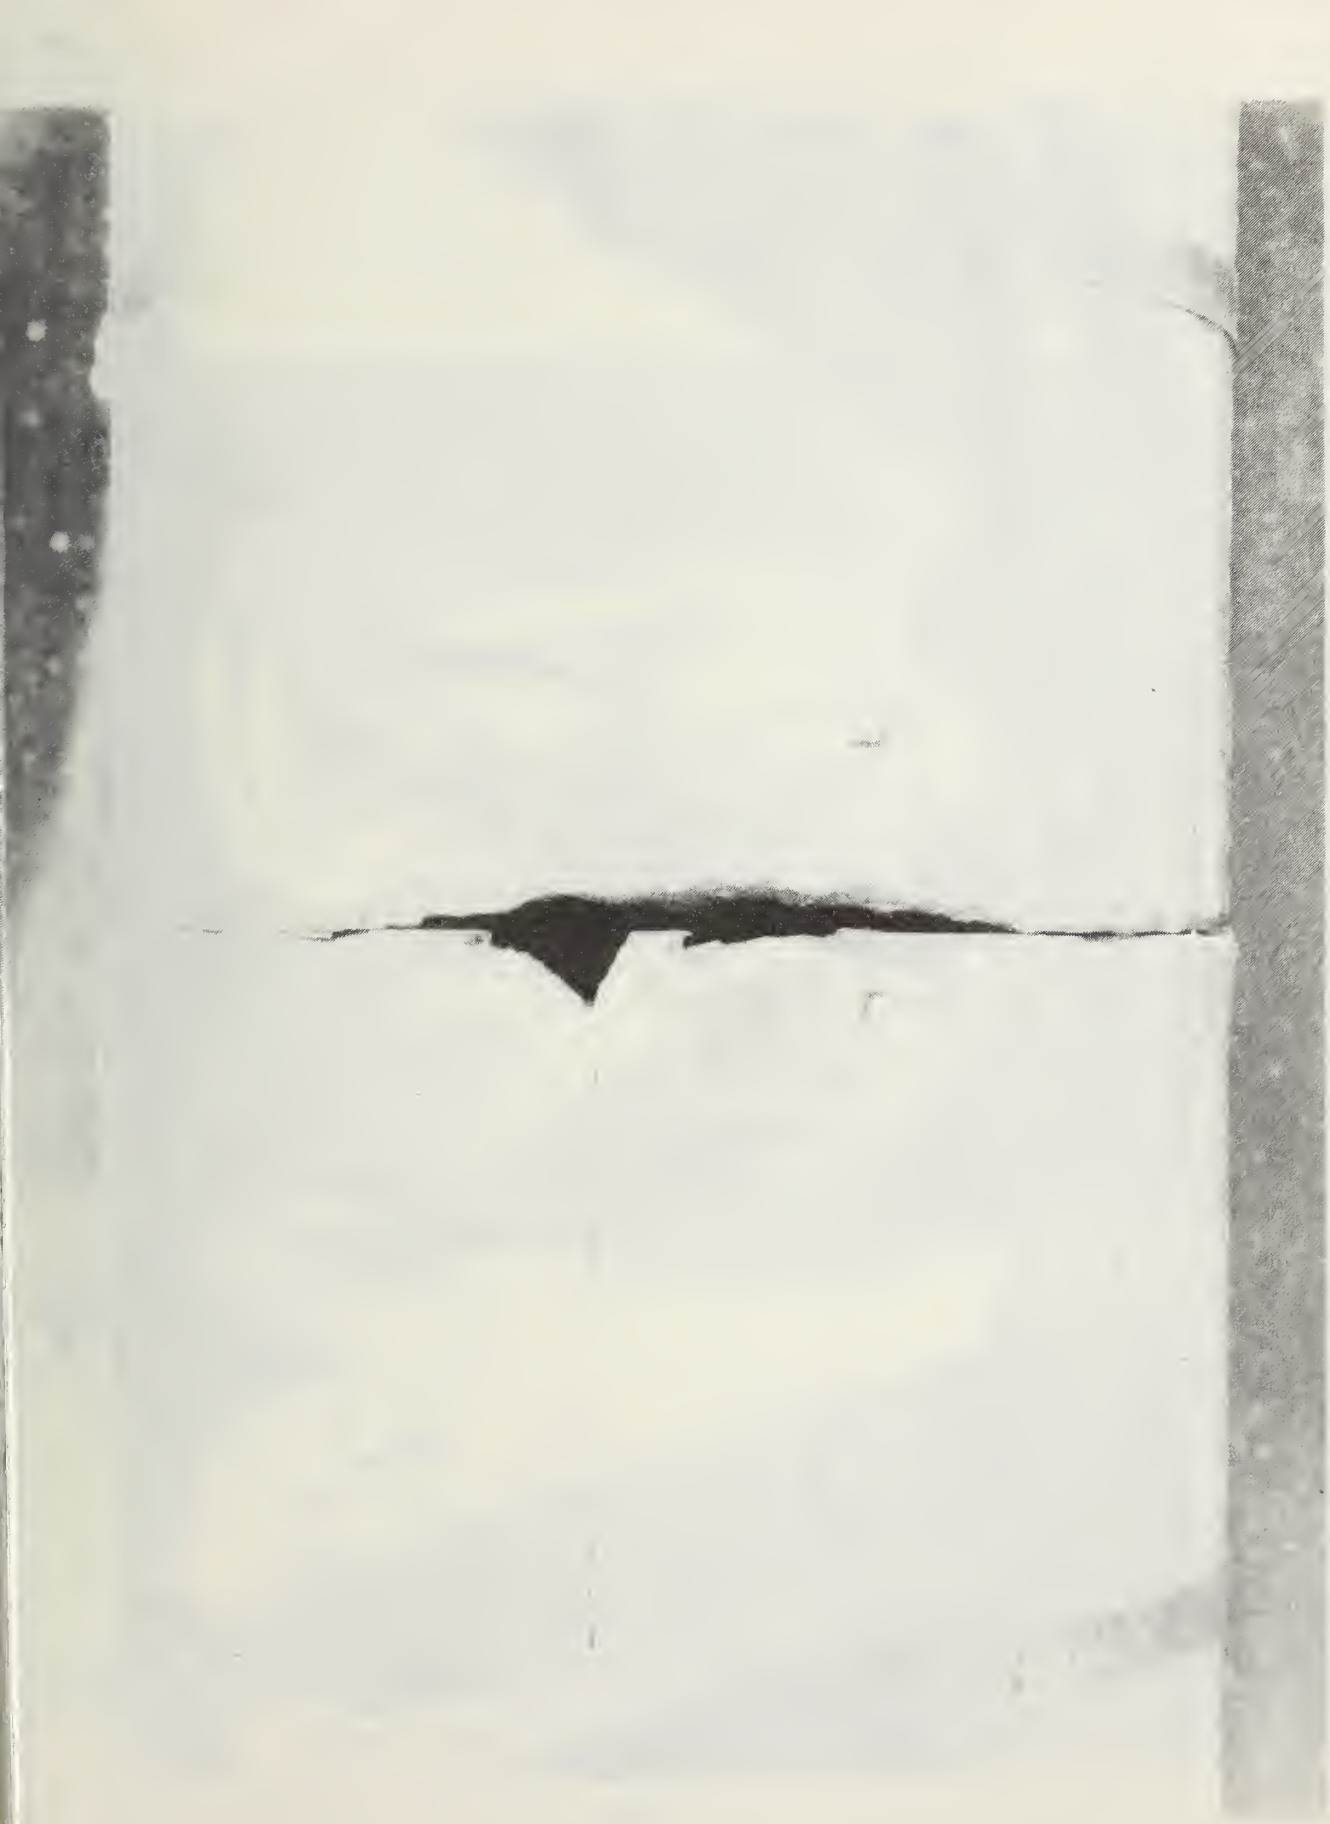
Figure 35. The joint of KAYLO-10 insulation jacket was eroded out by the boiling action of water outside the carrier pipe.

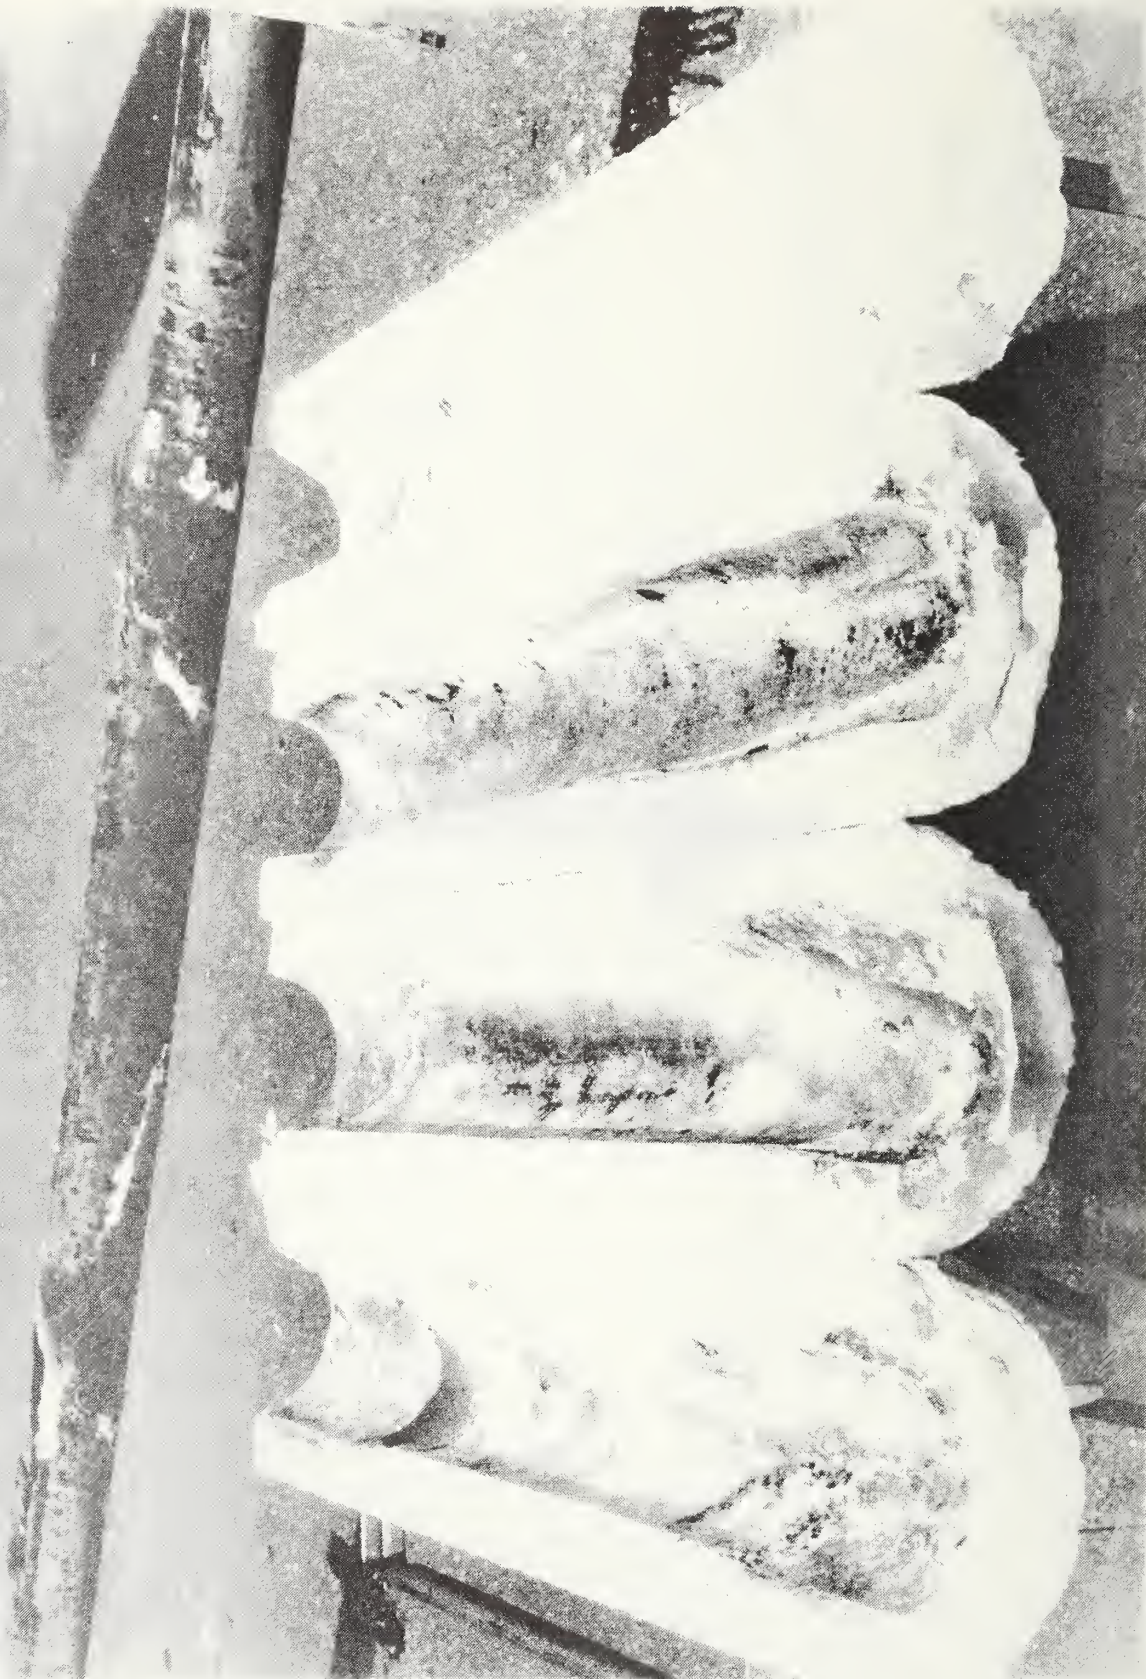
The pipe heat transfer factor for this particular underground system, therefore, increased more than 20 percent, which exceeded the Tri-Service criteria of ten percent. The system is considered to have failed the Tri-Service boiling test.\*

Figure 34. KAYLO-10 insulation after the boiling tests shows severe erosion due to the boiling action.

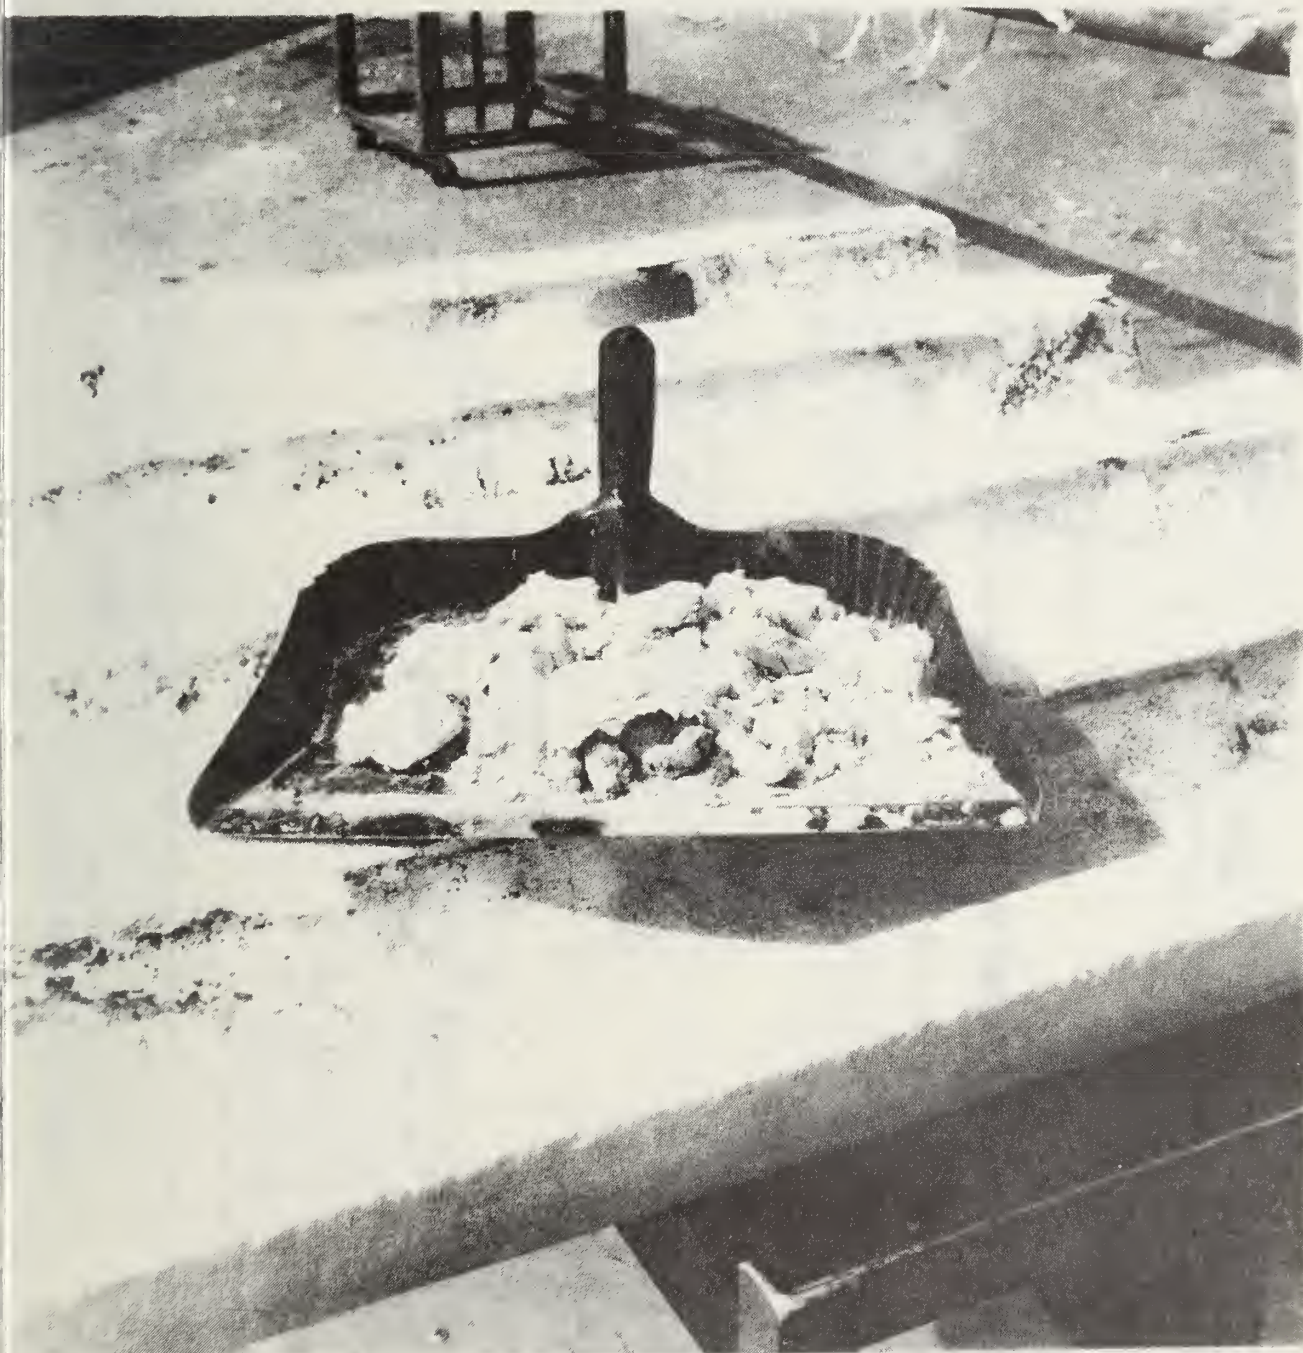
Figure 36. Crumbs of KAYLO-10 insulation found in the conduit space after the carrier pipe and insulation jacket were removed.
